Milestone Inspection Report

Project # 22RS-1267
February 9, 2024
FINAL COPY

Client:
***Excelsior Beach to Bay Owners
Association, Inc.***

RE: Excelsior Beach to Bay Structural Evaluation
6263 Midnight, Sarasota, FL 34242
KE File # 22RS-1267
Professional Engineering Services – Milestone Inspection

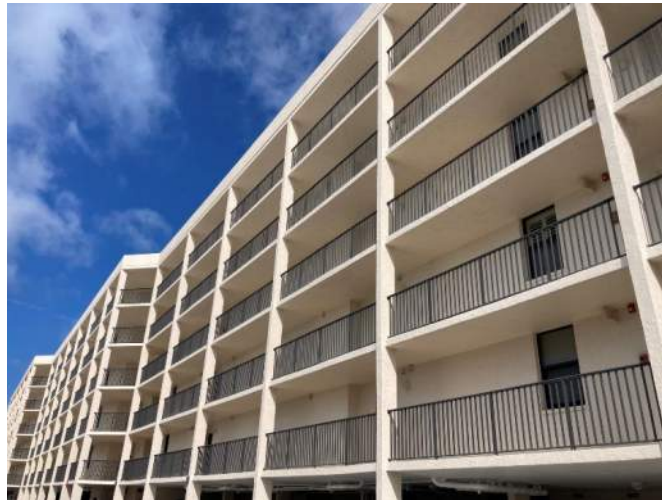
Figure 3: Columns at Gulf Building

Observations: No structural deficiencies noted.

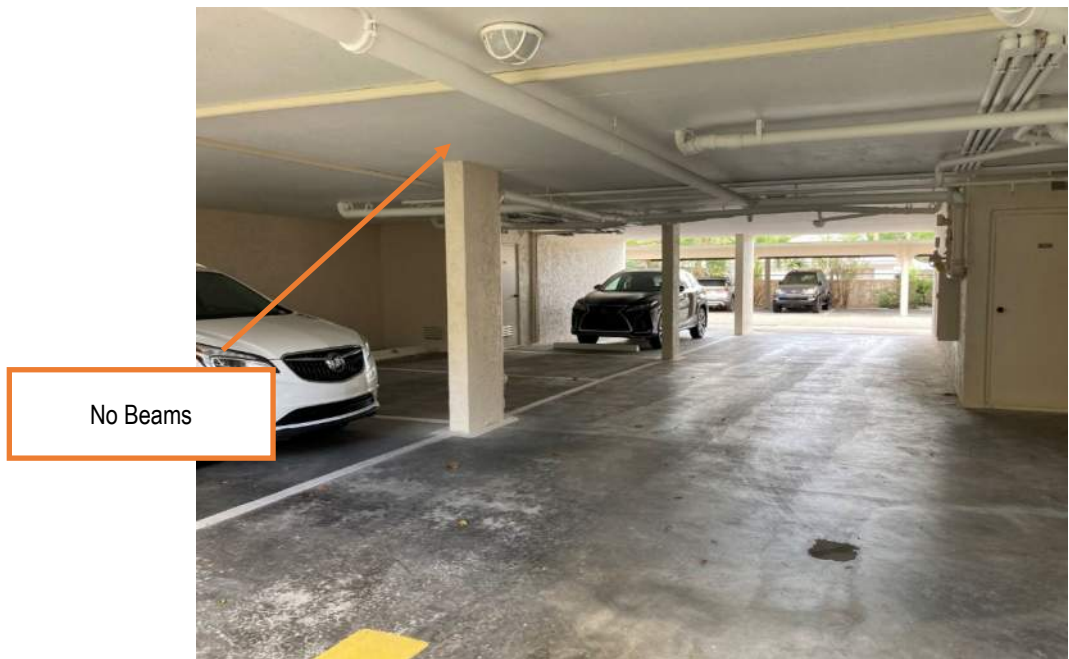
Figure 5: Flat Plate Construction at all buildings

Observations: No structural deficiencies noted.

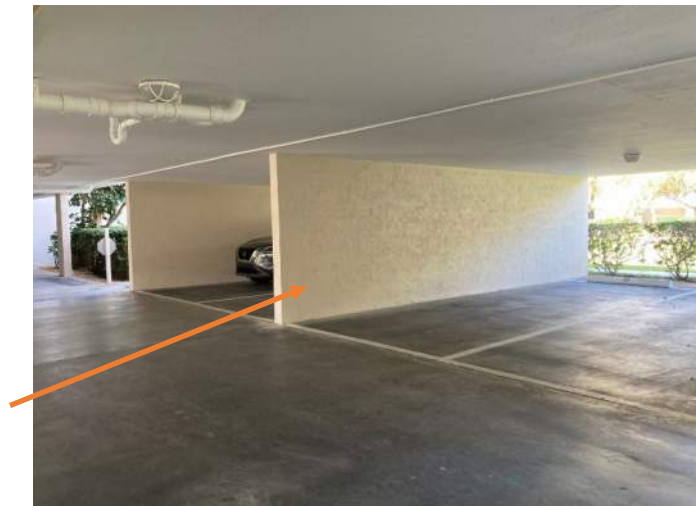
Figure 6: Typical Wall at all Buildings ground level

Observations: No structural deficiencies noted.

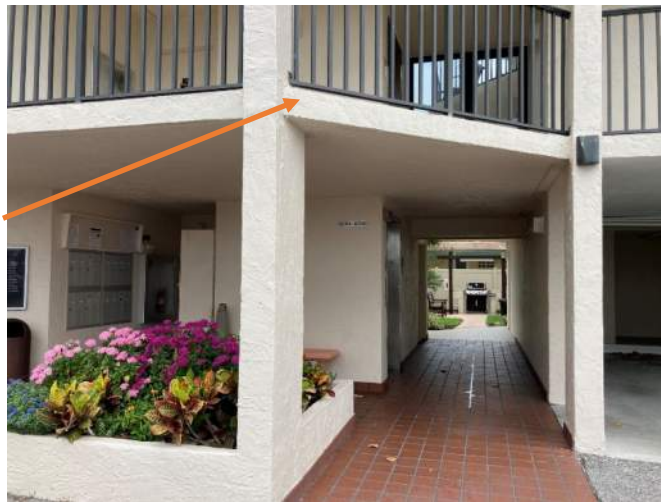
Figure 8: Typical Floor at the Gulf Building

Observations: No structural deficiencies noted.

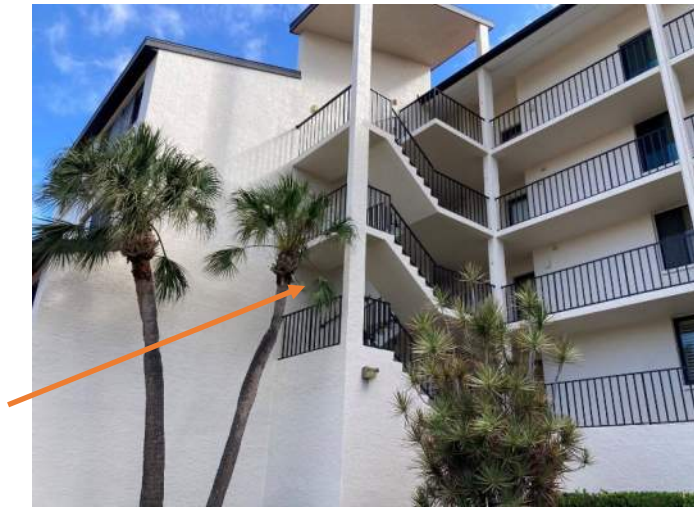
Figure 10: Typical Stairwall at Buildings 1 – 5

Observations: No structural deficiencies noted.

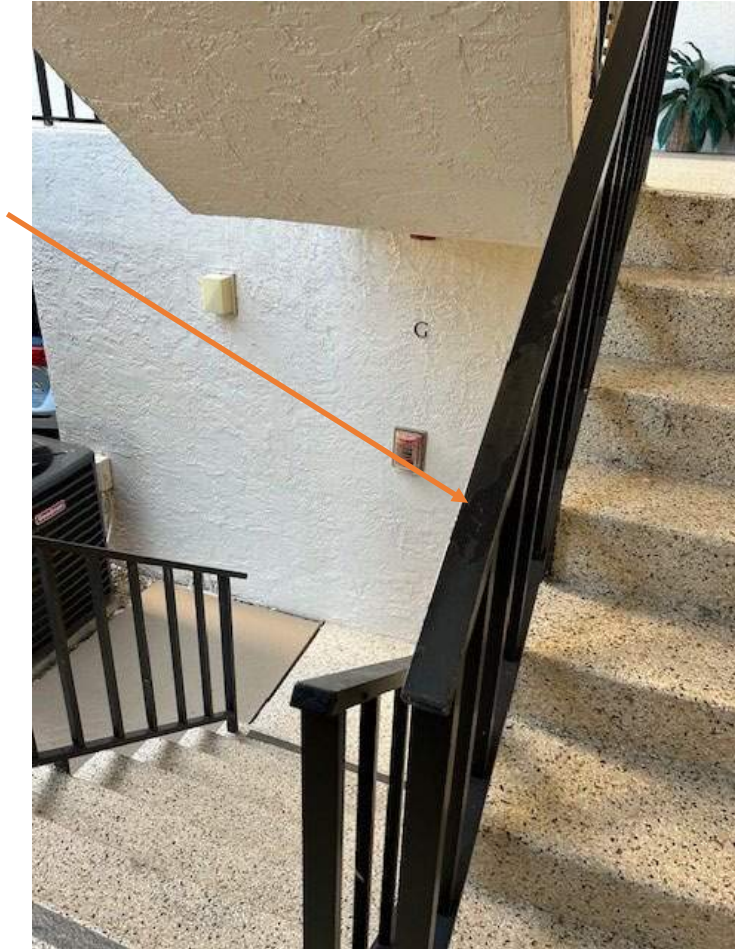
Figure 1: Peeling paint on handrail typical

- Repair all cracking of concrete in accordance with ICRI Guidelines
- Repaint flaking paint on handrails and monitor for adhesion
- Monitor previous stucco repairs for adhesion and delamination
- Fill voids where fire strobe lights have been installed
- Inspect foam seal at light fixtures. Apply sealant where foam has failed.

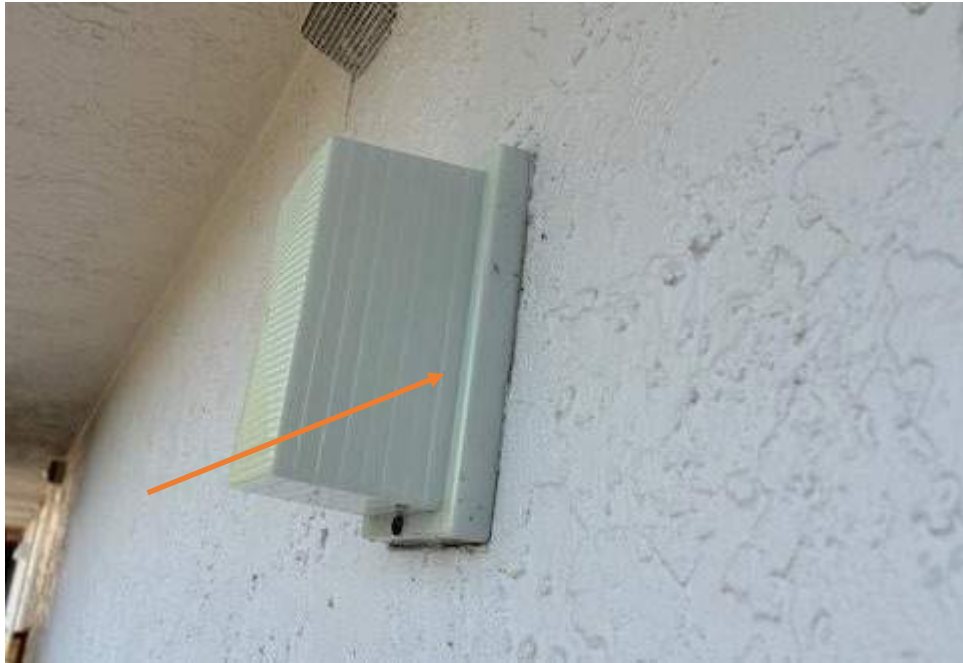
Figure 2: No sealant around light fixtures. Inspect foam seal regularly. Apply sealant if necessary

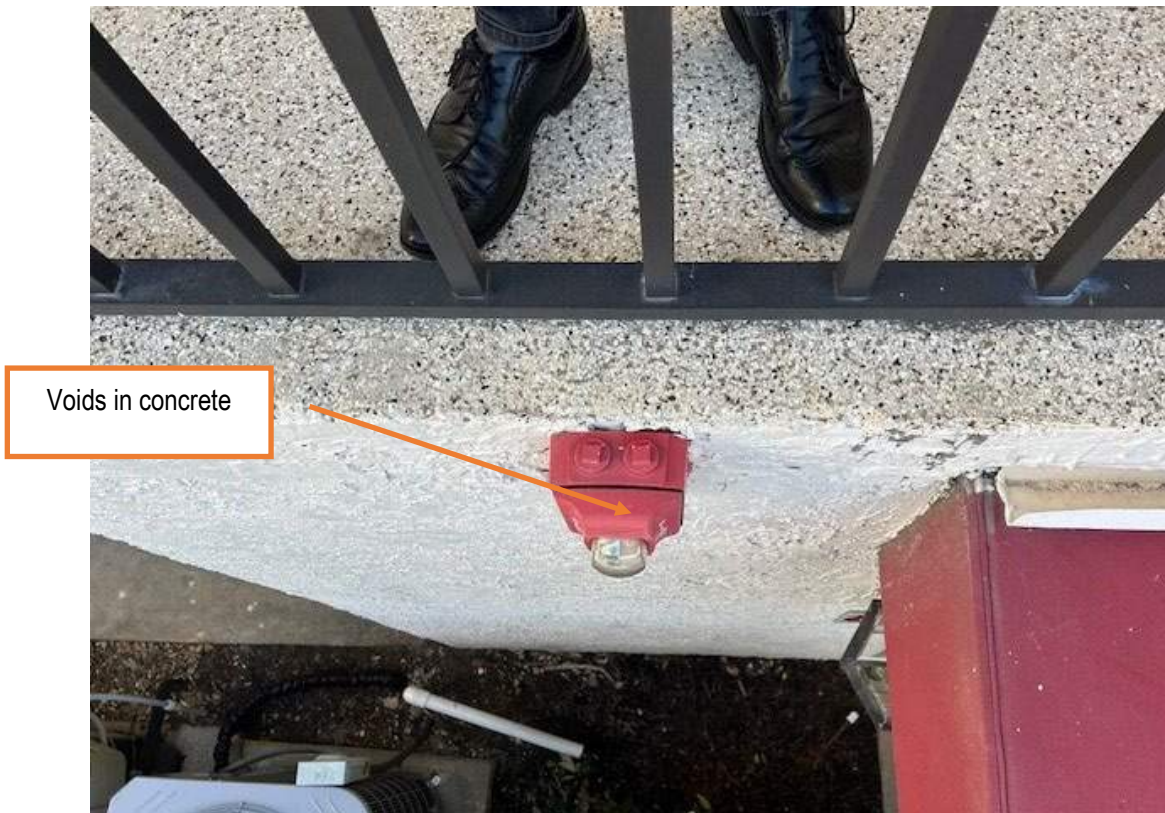
Figure 3: Opening at Strobes typical – apply sealant and fill void

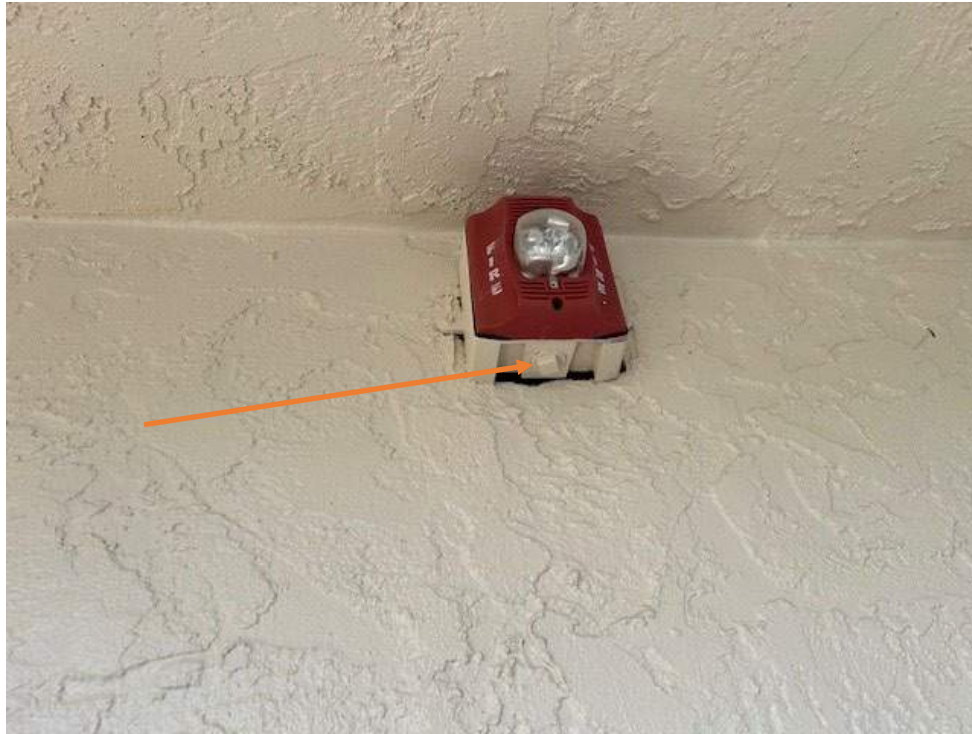
Figure 4: Vois at strobes typical

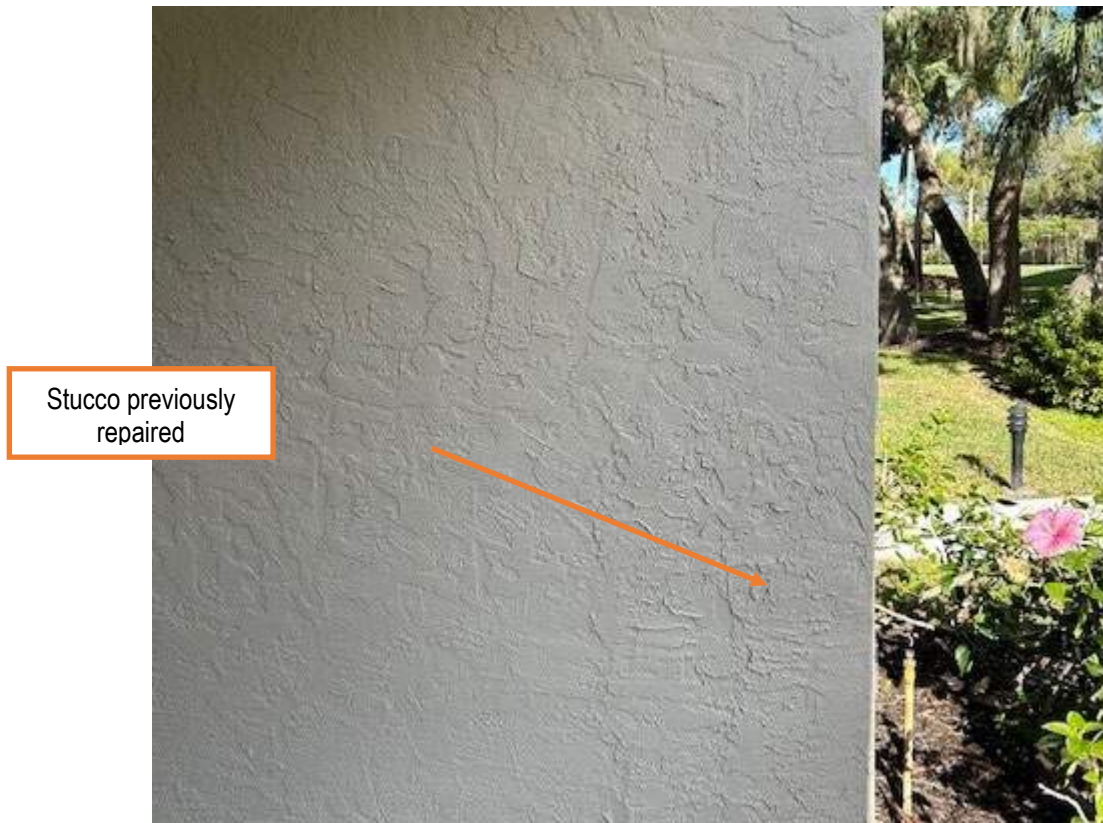
Figure 5: Monitor for delamination

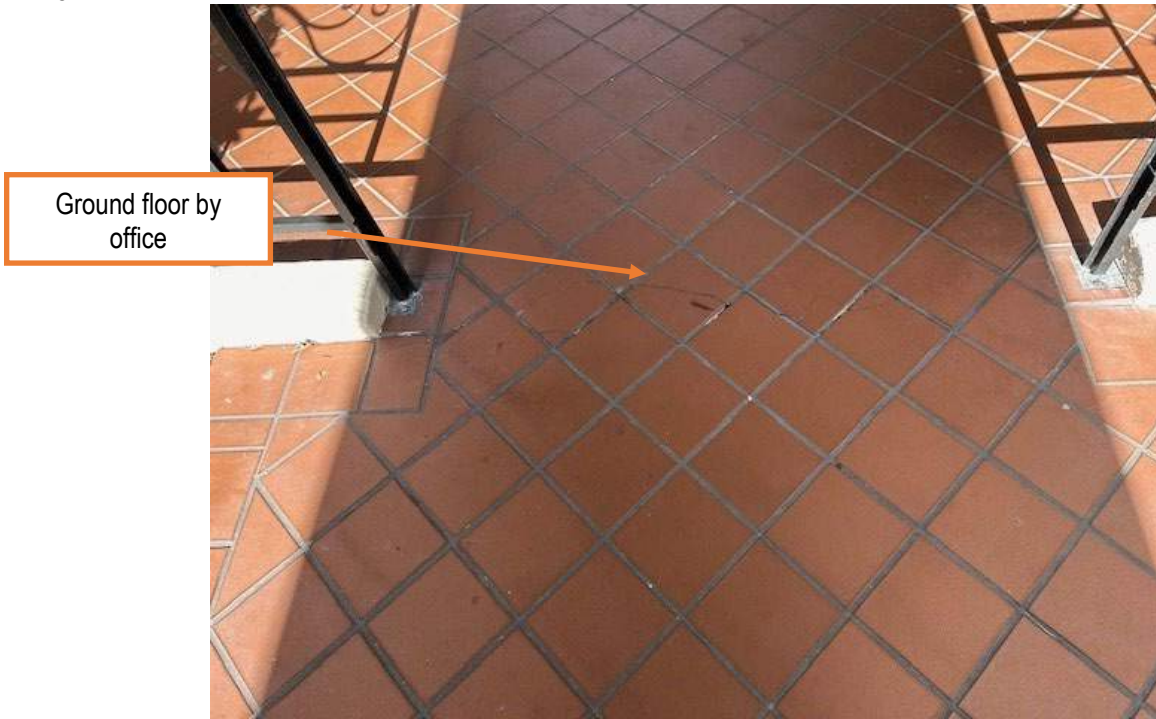
Figure 6: Cracked walkway tile

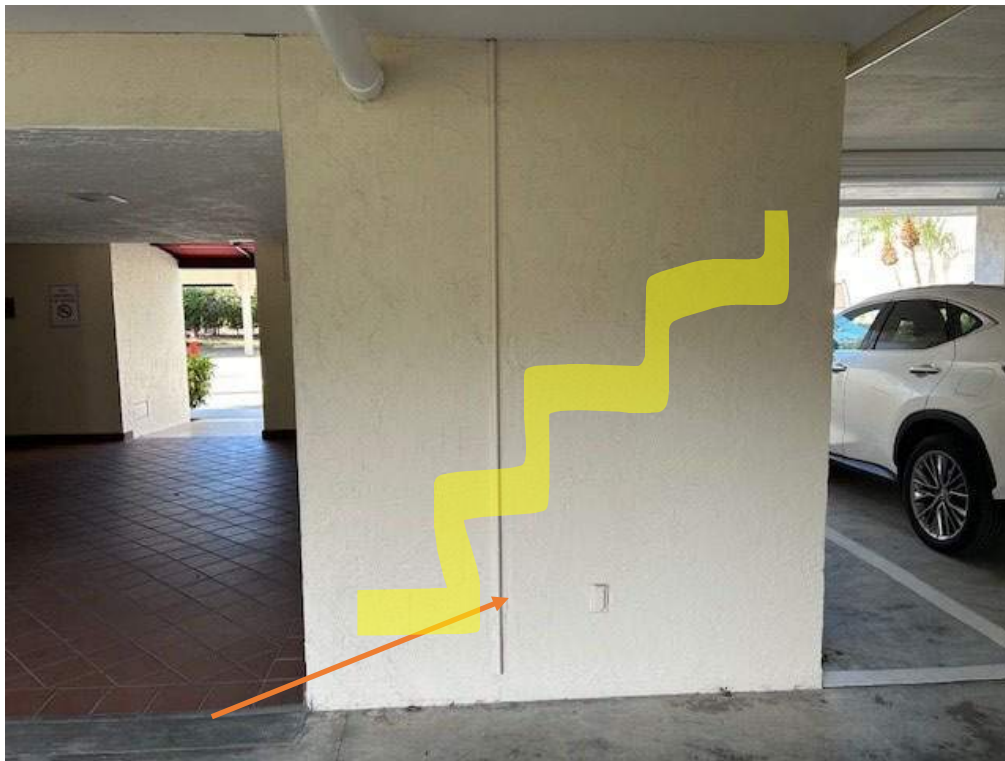
Figure 7: Stairstepping of CMU block in garage Typical
